This is an overview for swapping disc brakes from a later model Chevy LUV on to an earlier model equipped with drum brakes.

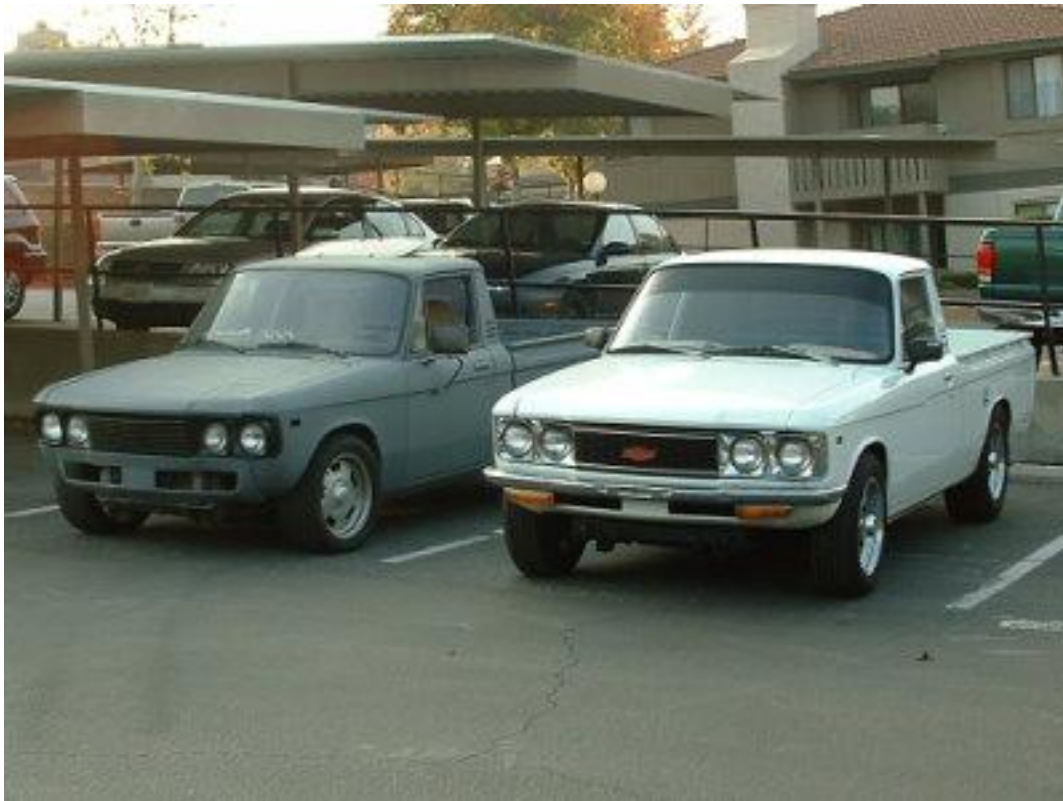
**On the left: 76 Chevy LUV (factory disc brakes)
On the right: 75 Chevy LUV (factory drum brakes)**

Aside from some cosmetic changes, the '75 and '76 are similar in stock form. But get behind the wheel of each, and you'll notice a big difference in stopping power. Although the stock drum brakes are among the best drum brakes I have used, they simply aren't as good as the discs for consistent all-weather-stopping and ease of maintenance. For those of you with engine upgrades, disc brakes up front are even more important.

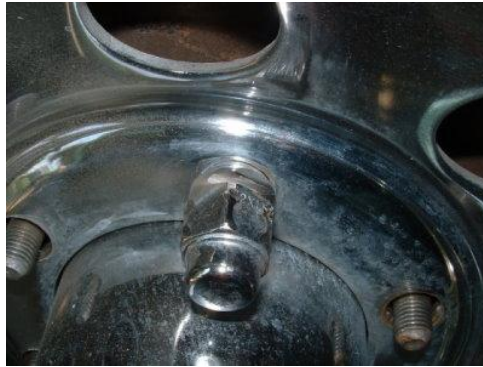
Stuck Lug Nut

First we raise the front and support it securely with jack stands, chock the rear tires, and then remove the front tires. Hopefully you don't get "lucky" like I did and find out that someone cross-threaded your lug nut for you. After exhausting all other options, I had to cut the nut off with a die-grinder. One hour later, I was finally able to remove the tire.

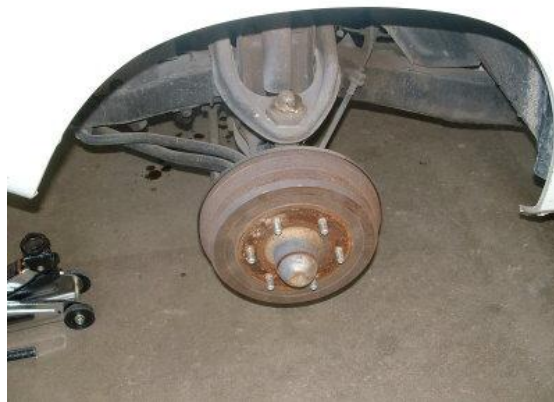
Final View of Stock Drums

I chose to replace the entire spindle because I couldn't remove my brake drums. They were grooved so badly that the shoes were holding them on and they were rusted to the hubs. To remove the whole spindle, the upper and lower ball joints have to be removed, as well as the outer tie-rod ends.

At this point **you can choose to leave the spindles on the truck** and just replace the brake parts, or do like I did and replace the whole spindle.

If you would rather just change the brake parts and leave the spindles, you'll need to remove the drums, the brakes and brake hardware, the hub and bearings, and finally the backing plate.

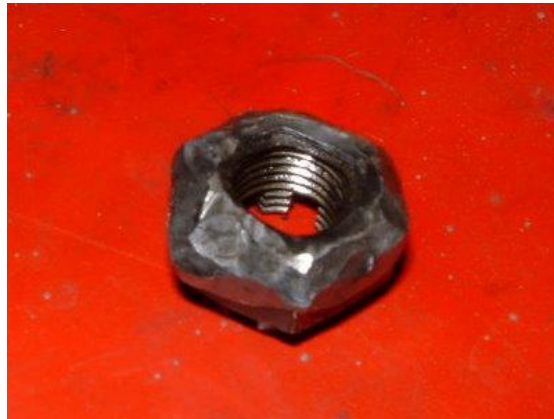
Damaged Castle Nut

Unfortunately, removing ball joints that have been installed for years, can be challenging. After unsuccessful attempts using normal methods of removal, I had to resort to more drastic measures. I decided to sacrifice this castle nut in lieu of damaging the threads on the ball joint studs. I threaded it upside down onto the threads and began the "persuasion" phase.

Unfortunately, finding a replacement metric castle nut was very difficult. After many days of searching, just when I thought I was going to have to buy a new ball joint just to get the nut, I found metric castle nuts at McMaster Carr. Don't waste your time looking at all the usual hardware or automotive chain-stores. Trust me, no one has them.

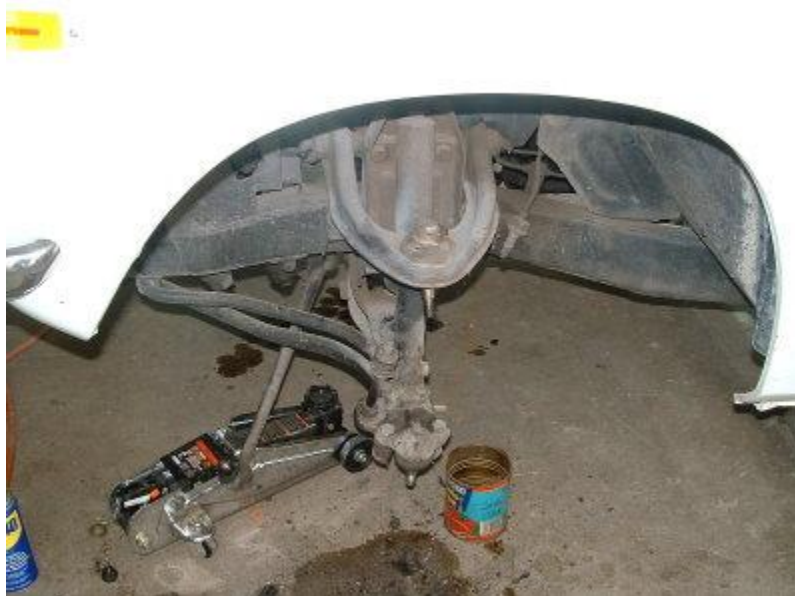
Spindle Removed

After lots of prying, pounding, kicking, and cursing, I finally got to this point. Things that have been on for 30 years, don't want to come off!

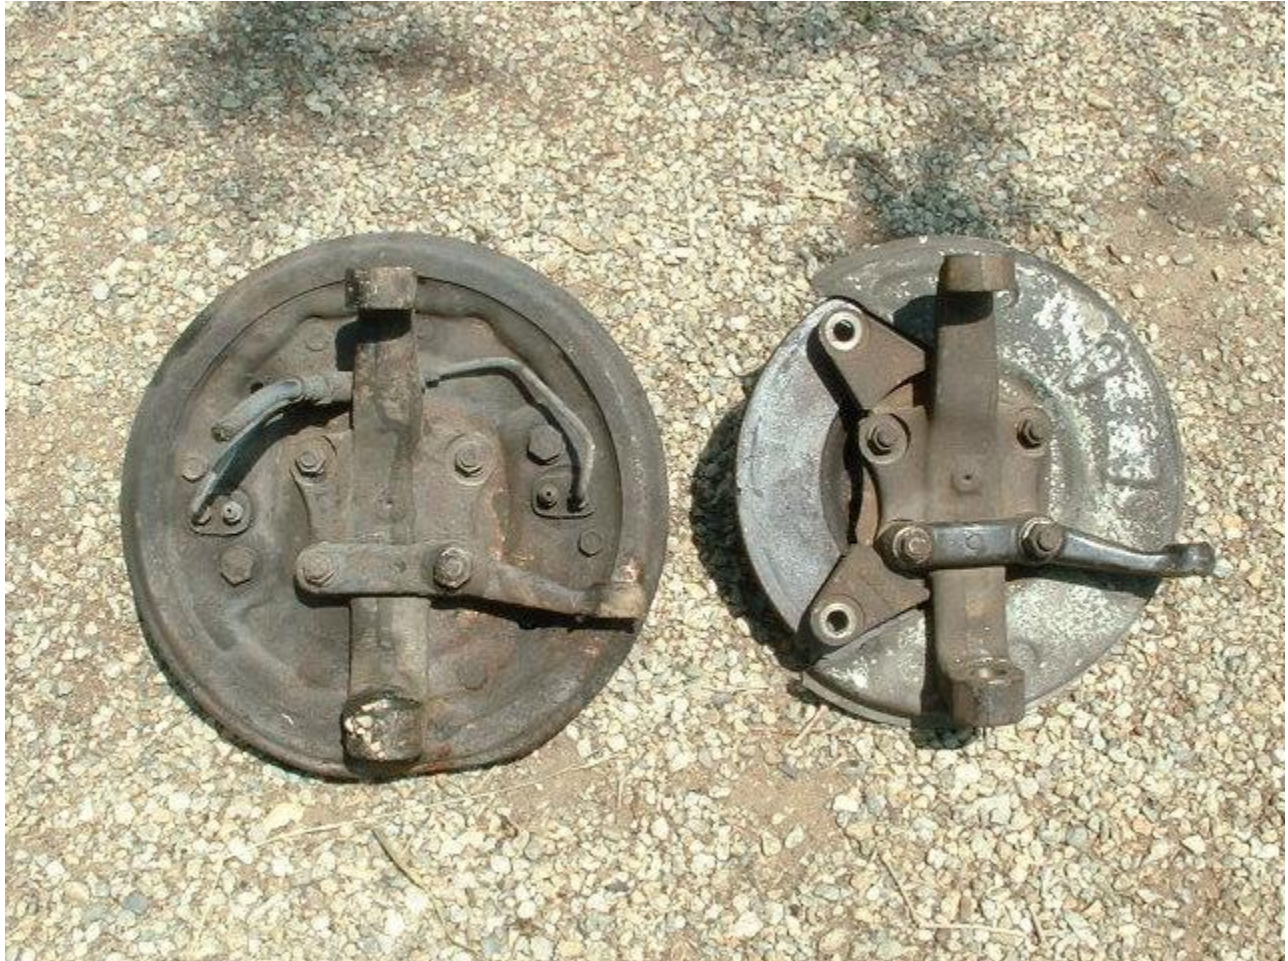
On the left: 75 Chevy LUV Factory Drum Brakes
On the right: 76-80 Chevy LUV Factory Disc Brakes

As you can see, the spindles are identical, sharing the same bolt pattern for the brake parts. Again, for some of you, **leaving the spindles on the truck and simply swapping the drum brake backing plate for the disc brake caliper bracket may be easier**. My "donor" parts were pulled from a truck in a wrecking yard but I don't know what year it was. I assume '76 thru '80 are the same.

At this point I completely disassembled the disc brake spindles and washed everything in parts cleaner. The wheel bearings were inspected and seemed OK. The rotors had large grooves in them so I took them to be turned. None of the repair shops would turn the rotors claiming that they were under the minimum thickness. Of course, everyone offered to sell me new rotors for the low-low price of \$100 each. Since I wasn't even sure if this was going to work, I decided to use the rotors as-is and buy new ones later.

After a good cleaning, the hardware was given a quick coat of black spray paint. Be sure not to get any paint on the bearing races if you decide to paint your setup. You should also not paint any part of the mating surface where the caliper and caliper bracket slide together. The wheel bearings were re-packed with disc-brake-compliant grease and everything was reassembled. Any repair manual will give you instructions on how to do this if you need help.

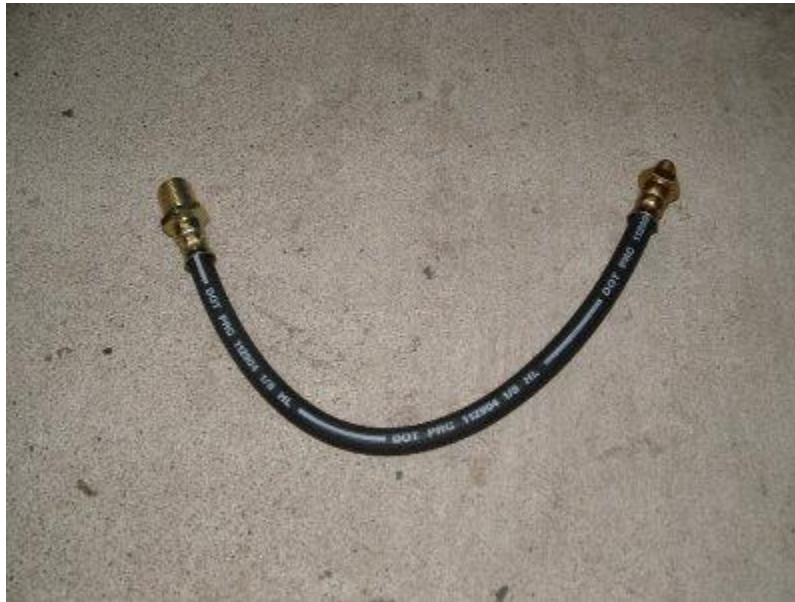
'76 Front Brake Hose from NAPA

Before starting this project I ordered new brake pads, rebuilt calipers, new brake lines, and a rebuilt master-cylinder for a '76 Chevy LUV from NAPA Auto parts. Everything seemed correct except for the brake lines.

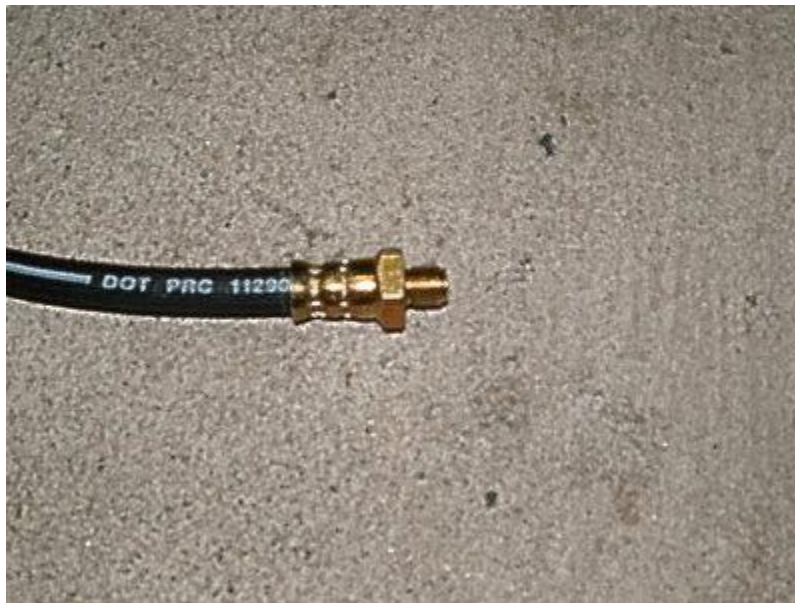
Wrong End

One end was useless and didn't attach to the caliper. This started a quest for the correct lines that sparked some debate on LUVTruck.com. I looked at a few other trucks in the wrecking yards but they were either drum or missing the front brakes. NAPA tried to tell me over and over that the lines were correct. Even Rock Auto.com seemed to list the same incorrect lines for the 76-80 disc brake trucks.

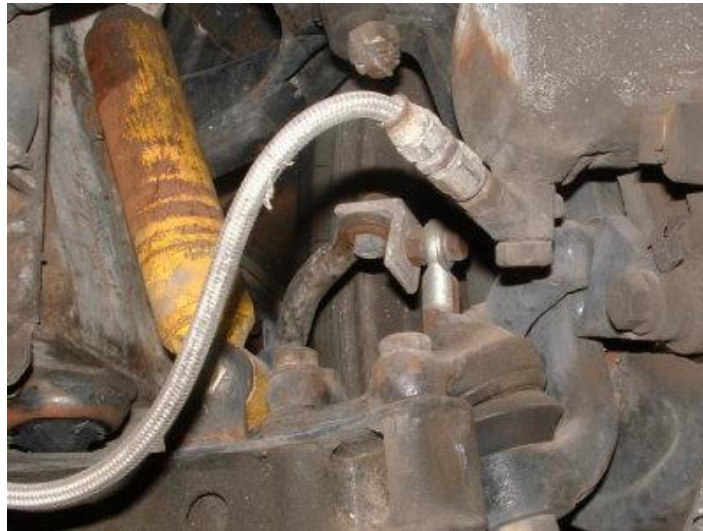
Custom Brake Lines for '76

I had my '76 as a reference which was equipped with disc brakes from the factory, but I had installed custom brake lines long ago and I was unsure about what part of the line was stock and what part was aftermarket.

To this day, I'm still unsure if I was missing a part, or if I was sold the wrong lines.

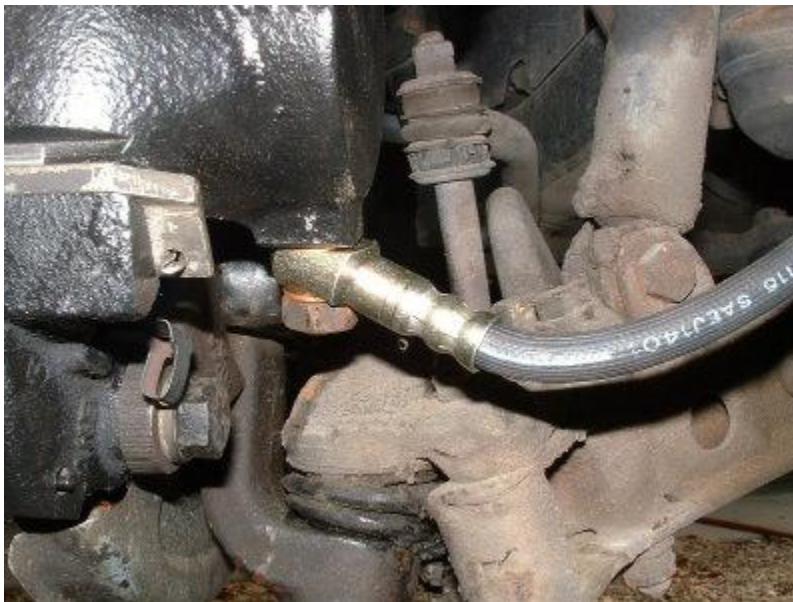
Custom Inexpensive Brake Lines

Eventually I got tired of the problem and went to a custom brake shop. In 10 minutes I had two inexpensive custom brake lines with the correct ends. If you go this route, be sure to tell them that the end that attaches to the truck frame uses metric threads and take them a caliper to match up a "banjo" to.

I wish I had simply gone to the brake shop in the first place.

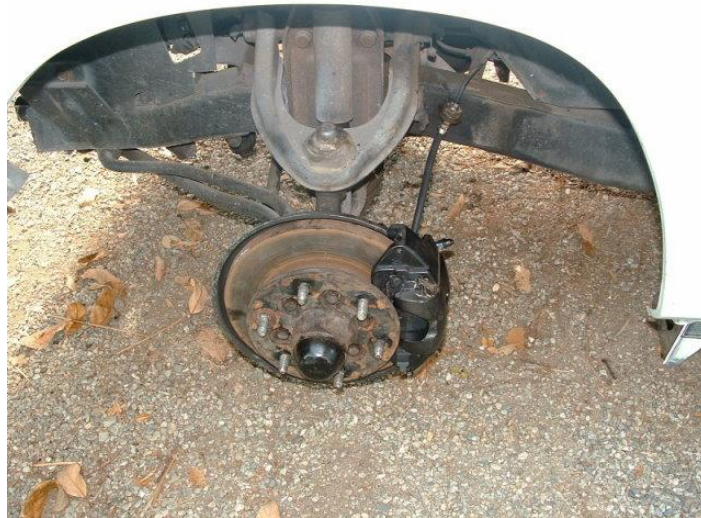
Disc Brakes Installed

Here is the completed assembly. Originally I had planned to do the swap on a Sunday, but with all of the complications, the project ended up taking a full week to complete during nights and weekends. Still, I think it was worth the effort.

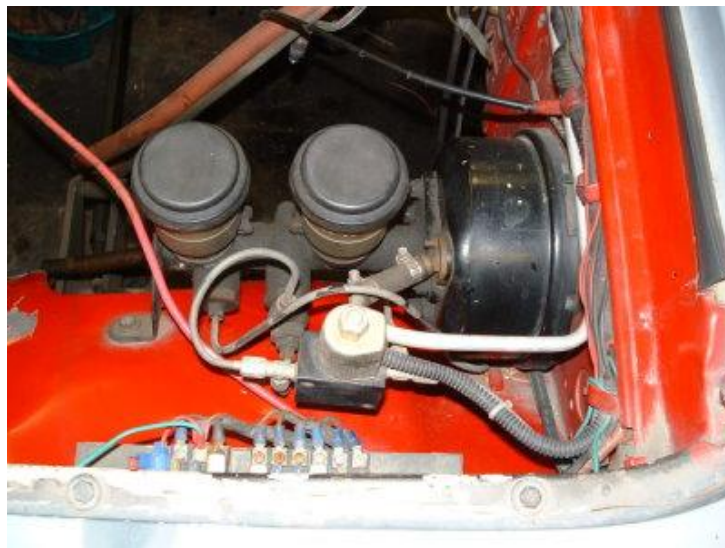
Master Cylinder

Externally, I couldn't tell the difference between the master cylinders for my '75 and my '76. But the experts at Karp's Brake Service assured me that there was some internal differences that could not be ignored when changing to discs. The master cylinder was a direct bolt-on replacement in my case. Neither my '75 nor my '76 have any kind of proportioning valve. Some trucks have them and some do not. I have also seen several different types of master cylinders out there so you may be in uncharted territory with your master cylinder. If you get stuck, the best advice I can give is to look up a local brake shop for help or give Karp's Brake Service a call.
